1/4 11 \mathscr{L}^{\sim} Rev. No. Page A Number SUPPORTING DOCUMENT of SD- WM-TI-260 Rev. 0 36 Waste Management Total Pages Document Title: · XXI No Baseline Document ☐ Yes Water Inflow Investigation at the WBS No. or Work Package No. 218-E-12A and 218-E-12B Burial Grounds WA4AA Prepared by (Name, Dept. No. and Signature) R.C. Routson, J.M. Calimann, D.R. Hyers, M.R. Adams, S. P. Luttrell (65630)
See reverse side for additional approvals Ditch Leakage, Perched Water, bentonite, corrective action THE DOCUMENT IS FOR USE IN PERFORMANCE OF WORK UNDER CONTRACTS WITH THE U.S. DEPARTMENT OF ENERGY BY PERSONS OF FOR PURPOSES WITHIN THE SCOPE OF THESE CONTRACTS. DISEMINATION OF ITS CONTENTS FOR ANY OTHER USE OF PURPOSES EXPRESSLY FORBIDDEN Distribution Name Mail Address Department of Energy -Richland Opertaions Office Abstract llevaris FED/625/700 Nater inflow observed in trench 36 in the A. R. Schwankoff FED/625/700 213-E-12B burial ground was feared to occur in a much larger portion of the 218-E-12B burial Rockwell Hanford Operations ground and to possibly extend to the 218-E-12A R. Adams (2) burial ground. Emplacement of investigation 2750E/200E trenches and wells were utilized to demo

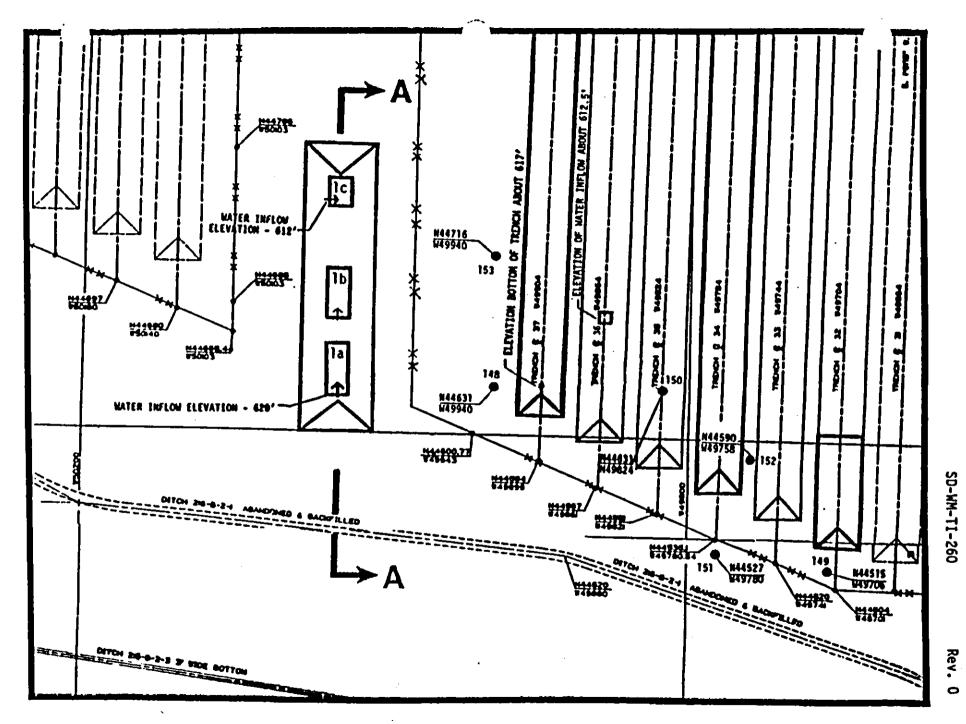
Water inflow was observed in unfilled burial trench 36 in the 218-E-128 (E-12B) burial ground (Figure 1 and Figure 2). Water flows into the trench at the 612.5 ft elevation and runs for about 85 ft along the trench bottom before percolating into the sediments. The flow rate has been estimated to be about one gallon per minute but it has not been confirmed.

Figure 2. Location of burial trenches, boreholes and excavation trenched in the 218-E-128 burial ground near burial trench 36. Filled burial trenches are accented in black.

On the opposite side of the affected area in E-128 burial ground borehole 148 was emplaced near the southeastern end of trench 37. In borehole 148 saturated sediments occurred at the 618 ft elevation. The bottom of trench 37 is located at 615 ft elevation adjacent to borehole 148 and water inflow likely occurred to a depth of about three ft.

Borehole 153 was emplaced about 85 ft north of borehole 148. Saturated sediments occurred at an elevation of 608 ft. The bottom of trench 37 adjacent to borehole 153 is at 611 ft. Saturated sediments occur three ft below the bottom of the trench 37. Thus water inflow is likely restricted to the southern 65 ft of trench 37.

Trench 34 is the only other closed burial trench which may have received water inflow (Figure 2). Boreholes 151 and 152 were emplaced for evaluating if burial trench 34 received water inflow. Borehole 152 is located about 30 ft north of the south end, and five ft to the east, of trench 34. Saturated sediments were present in borehole 152 at an elevation of 608 ft. The bottom of burial trench 34 is located at the 615 ft elevation adjacent to borehole 152. Thus water inflow did not occur in trench 34. Borehole 151 is located about 40 ft south of trench 34. Saturated sediments are present at the 609 ft elevation in borehole 151. The bottom of trench 34, adjacent to borehole 151, is at the 616 ft elevation. Thus water inflow into trench 34 is not indicated. The data from boreholes 151 and 152 are in good agreement.

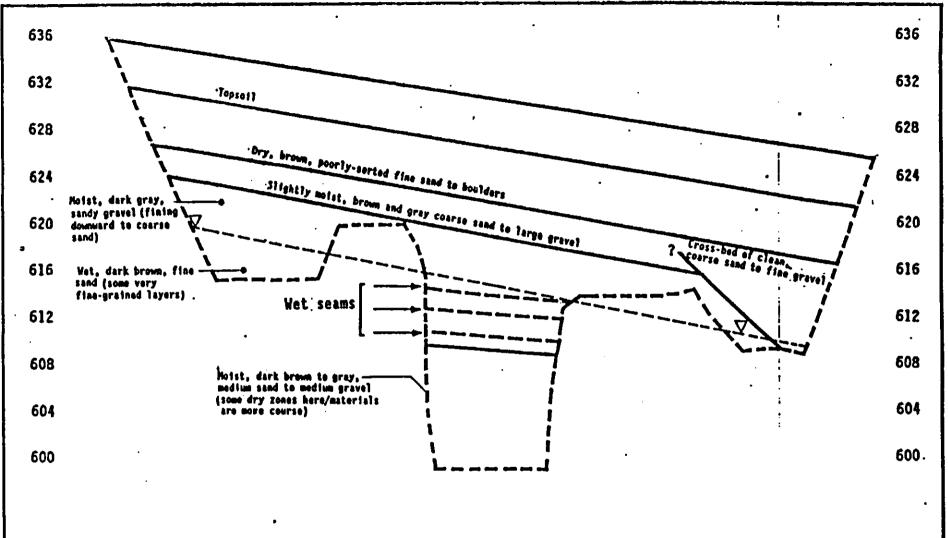
A geologic profile the length of the three investigation trenches is provided in Figure 3. The geology across the length of the excavations is complex and difficult to describe in detail. Cross-bedded, poorly sorted sand, gravel, and cobble extend to a depth of 10 or 12 ft.

Figure 3. Geologic Profile of the Interceptor Trench Constructed West of the 218-E-128 Burial Grounds.

Saturated materials were encountered at the 620 ft elevation in the southern most investigation trench (1a, Figure 3). Water readily flowed through coarse sand and gravel into the southern end of the excavation. This rapid inflow indicates a steep hydraulic gradient to the north. The water appeared to be perching above a thin silty sand layer. In the 1b investigation trench saturated sediments occurred at an elevation of 615 ft. Saturated sediments also occurred at the 613 and 611 ft elevation. Saturated sediments occurred at the 612 ft elevation in the 1c investigation trench. Water readily flowed through coarse sand and gravel and was perched above a thin layer of silty sand.

An initial generalized hydraulic gradient was estimated from the upper elevation where saturation occurred in the investigation trenches and trench 36. In all three investigation trenches the saturated elevation is likely controlled by a combination of the occurrence of thin layers of silty sand and the leakage through these layers as water flows from the B-2-3 ditch.

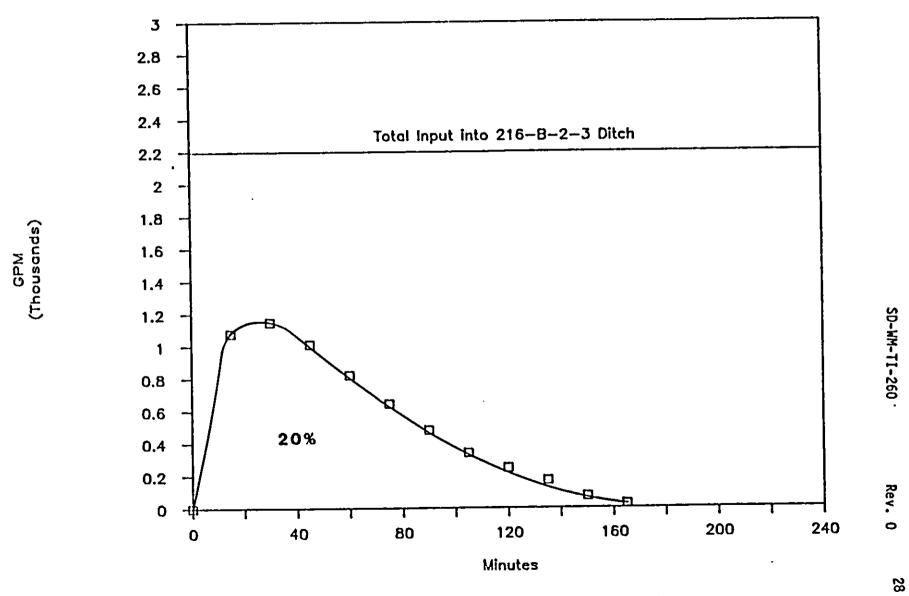
A recent inspection of the condition of the B-2-3 ditch revealed that the ditch is severely plugged by a series of dams that are composed of tumbleweeds, reeds, silt and other debris that has accumulated in the ditch over the past few years. A total of twelve dams were found in the ditch. The inspection was conducted during the emptying of one of the retention basins and it was apparent that virtually all of the water was being retained in the ditch and allowed to percolate into the soil.

A trapezoidal weir at the discharge end of the B-2-3 ditch was put back into service and the discharge from the ditch was measured. As shown in Figure 11 less than 20% of the water entering the ditch was being discharged from the ditch. Conversely, 80% of the water, or 2,500,000 gal. per day was percolating into the coarse sands and gravels in the ditch, indicating that the B-2-3 ditch is the source of the water seeping into trenches 36 and 37 in the 218-E-128 burial ground.

FIGURE 11. Discharge from 216-B-2-3 Ditch

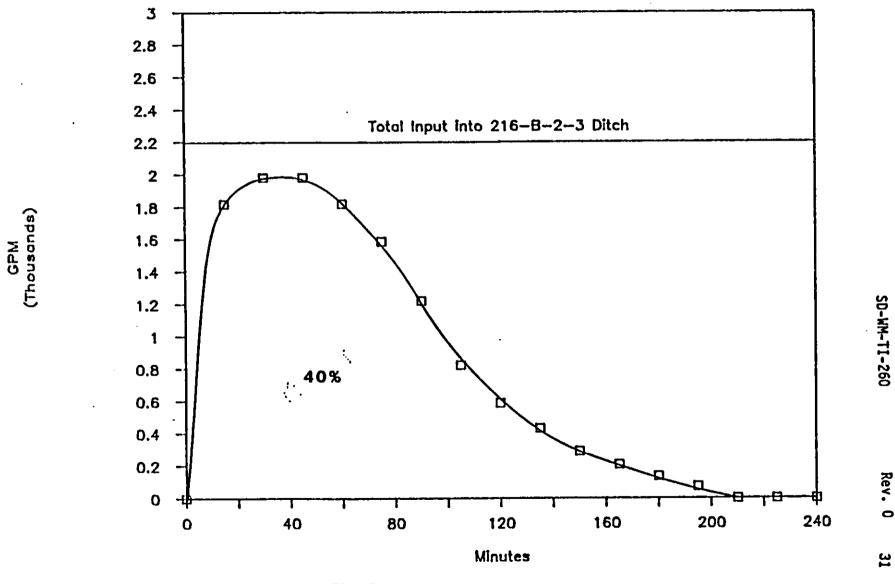
FIGURE 12. Discharge from 216-B-2-3 Ditch After Bentonite Application

Based on the manufacturer's recommendation, a granular bentonite was applied to 2400 feet of the B-2-3 ditch at a rate of two pounds per square foot. The bentonite was applied starting 400 feet from the beginning of the ditch and extending 2400 feet to the cross-over road in the burial grounds. A cement bucket and crane were used to apply the bentonite as evenly as possible to the bottom and sides of the ditch. Granular bentonite is the texture of coarse sand and is easily applied through standing vegetation and water. After being applied, the bentonite absorbs water, swells by up to a factor of ten and forms an impervious clay liner on the bottom and sides of the ditch. The flow rate at the trapezoidal weir was again monitored after the bentonite application. Approximately 40% of the water entering the ditch was being discharged from the ditch. The bentonite effectively doubled the amount of water being discharged, as shown in Figure 12.

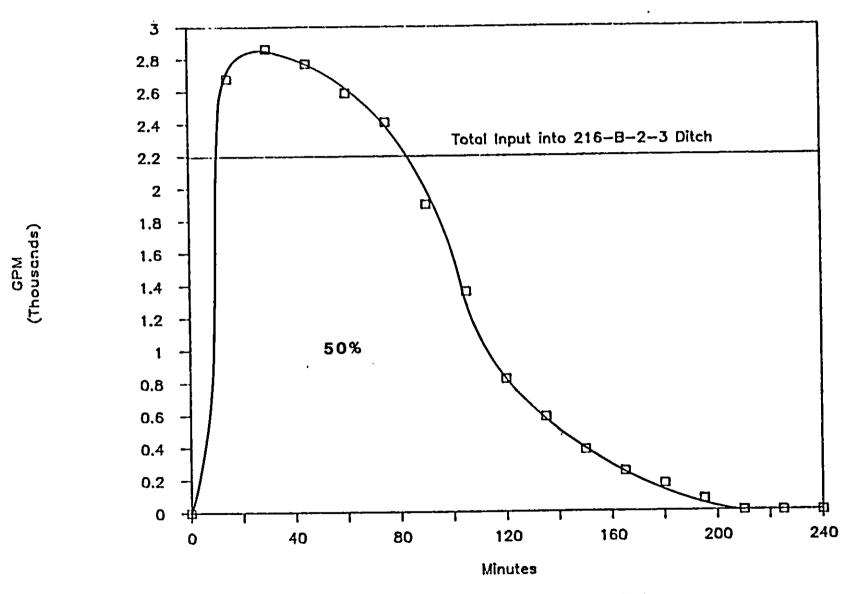
FIGURE 13. Discharge from 216-B-2-3 Ditch Bentonite A ication and Dam Cleanout

Approximately one week after application of the bentonite was completed, work began to remove the tumbleweed dams and obstructions to the flow of water. The twelve dams were removed and disposed of using a smooth lip clam shell bucket, crane, loader and 10 yd. dump truck. Care was taken in removing the dams to minimize the disturbance to the ditch sides and bottom so the infiltration rate was not increased. The flow rate at the trapezoidal weir was again monitored after removal of the dams. The flow rate had increased such that 50% of the water entering the ditch was being discharged from the ditch. The flow rate is shown in Figure 13.
